**Removal of Aquatic Weeds From Lagoon Creek,  
Herbert Catchment North Queensland: Trialling  
Novel Removal Methods and Demonstration of  
Environmental Benefits**

ACTFR Report No. 07/15

June/2007

Prepared for  
Great Barrier Reef Coastal Wetlands Protection Program  
Department of Environment & Water  
Canberra

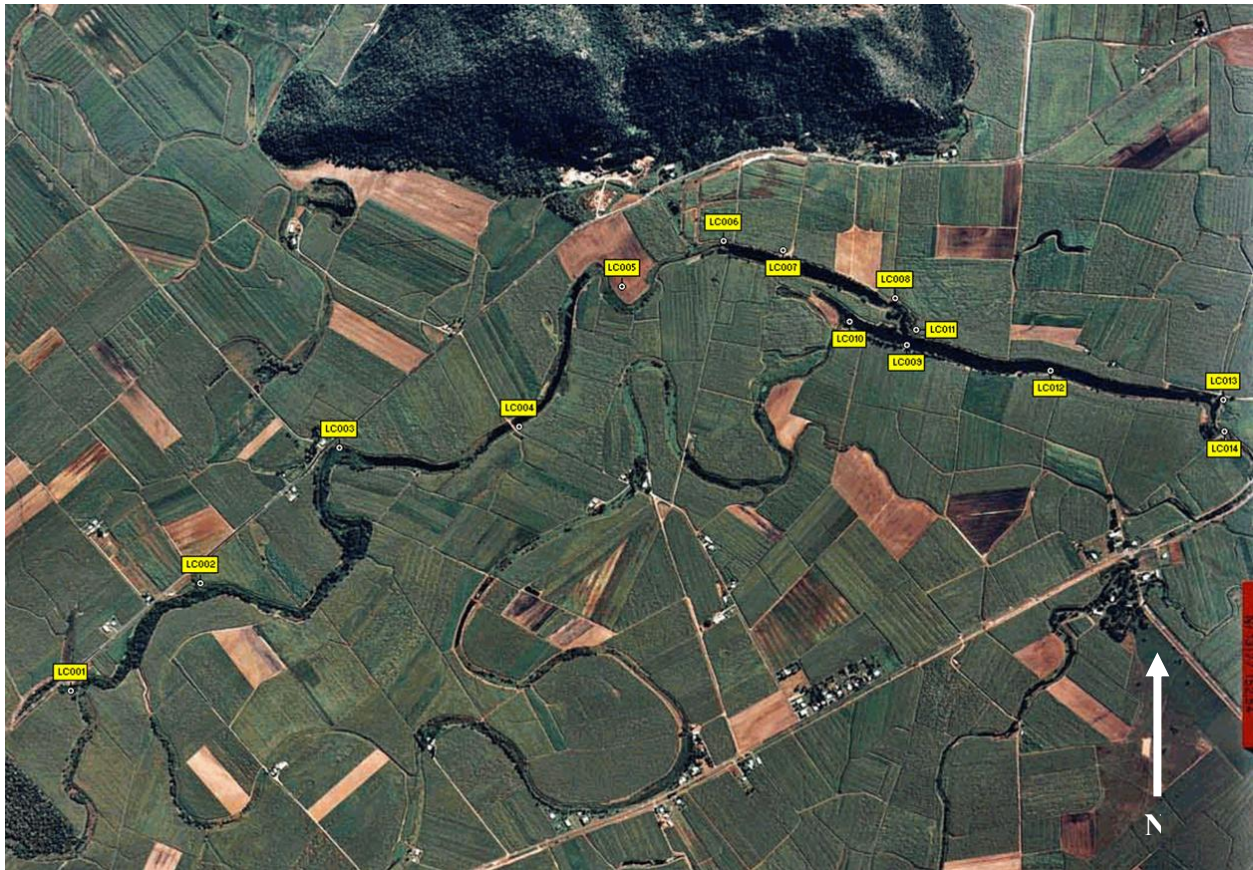
**Figure 1** Sampling and Reference Sites on Lagoon Creek

Baseline photographs were taken at each site for future reference and comparison between before and after harvesting of the floating weed mats. Flora and fauna (birds and fish) were observed briefly at each site and recorded. Details of sampling and reference sites are provided in Table 1 and Figure 1.

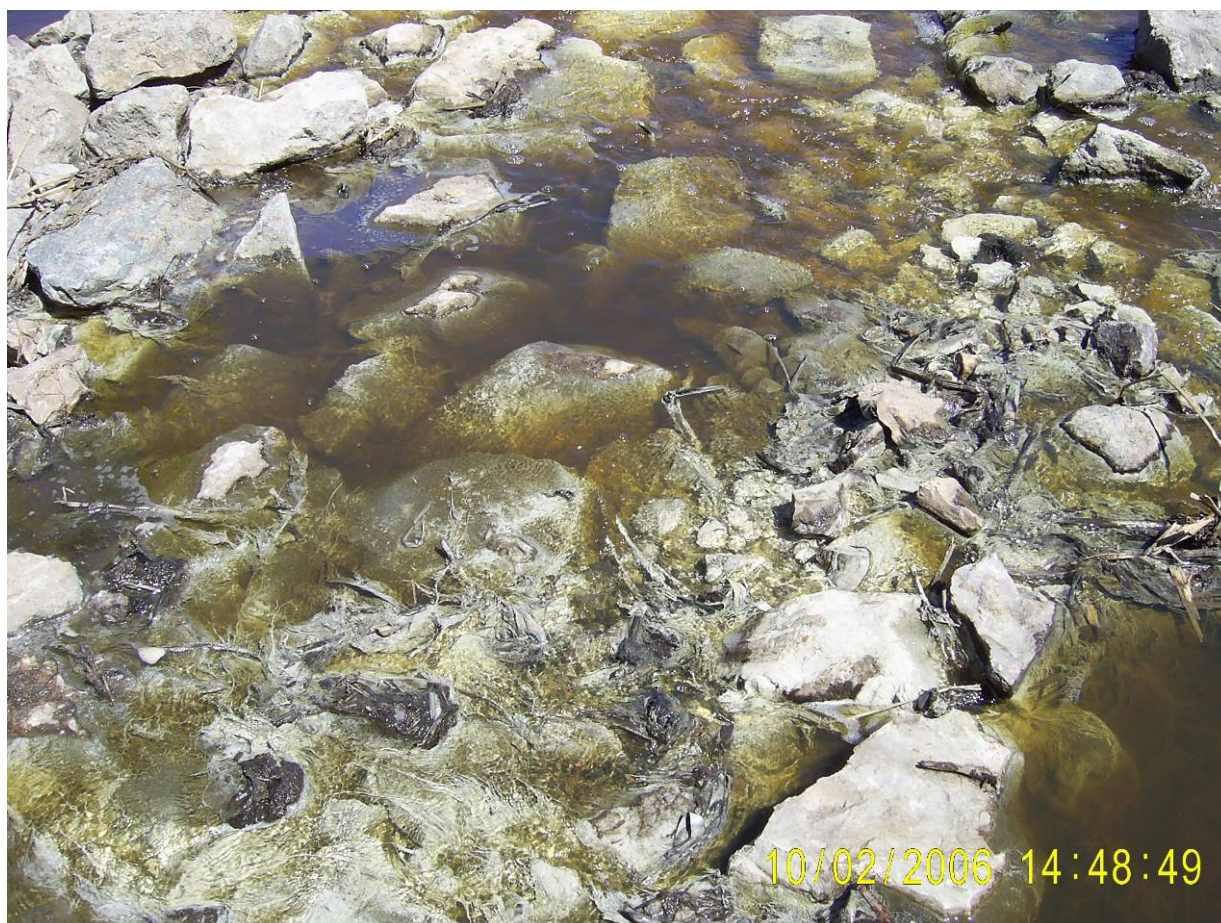
**Figure 2** Water flowing over the tidal barrier at site 4 showing water colour and white benthic growth

White plant-like matter growing on rocks at the barrier may have been sulfidic bacteria although identification was not undertaken (Figure 2). The water had an intense grey/brown/black coloration (Figure 2) suggestive of high levels of tannin or dissolved organic matter (DOM). The highest DO value recorded at this site before harvesting was undertaken was 6.8% saturation. This was recorded by an automated Hydrolab data-logger prior to the commencement of any flows under the weed mat.

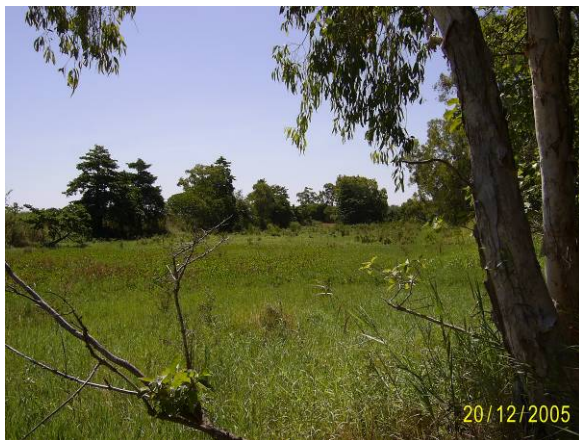
**Figure 4a** Site LC007 in January 2006

Prior to December 2005, Lagoon Creek was almost completely covered in a mat of weeds with a primary infestation of water hyacinth supporting a secondary invasion of a range of species including *Sporobolus virginicus*, *Urochloa mutica*, *Alternanthera philoxeroides*, *Potamogeton sulcatus*, *Cyperus eragrostis*, *Melaleuca* species and a range of other plants growing on top of the hyacinth mat in over 3 metres of water in some locations by January 2006 (Figure 4a and b) but was open water in January 2007 after weed removal (Figure 4c and d).

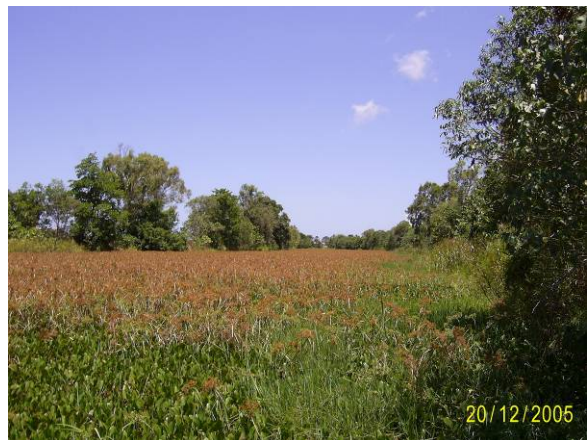
**Figure 4b** Site LC012 in January 2006

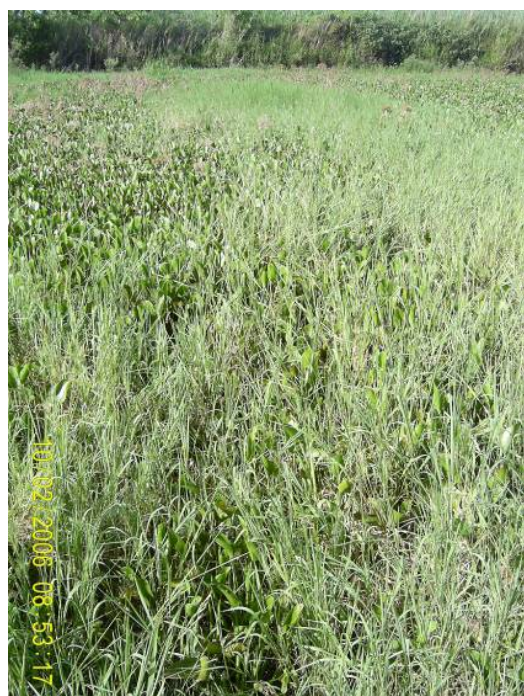
**Figure 5a** Pre Spray Weed Mat

The effect of salt spraying varied with the volume and concentration of salt applied. Before and after photographs of the trial are shown in Figures 5a-f and results of the assessment of the field trial are given in Table B3. These results led to the recommendation to apply 100Kg of Sodium Chloride (NaCl)/450 litres water, to each half hectare as described in the methods. No Magnesium Sulfate (MgSO<sub>4</sub>) was added to the solution.

Final observations confirmed that the most cost-effective rate of application was 200gm/litre at 100ml/m<sup>2</sup> which had a rated effect of 4 (Figure 5e). Photographic images of the response to various applications are at Figures 5a-f.

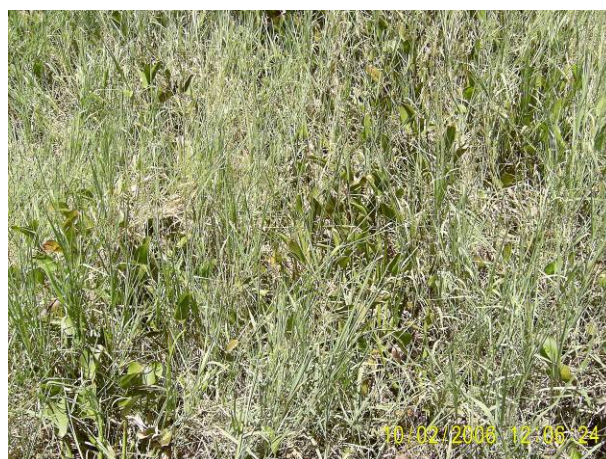
**Figure 5b** Brine effect 3 hrs after spraying with 140gm/L at 50ml/m<sup>2</sup> after 3 hours

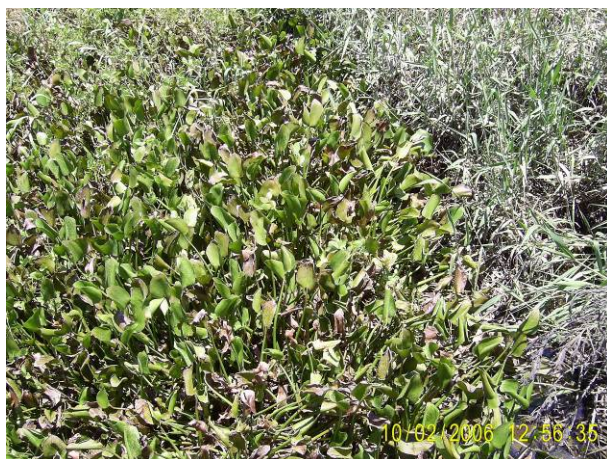
**Figure 5c** Spraying with 100gm/L at 200ml/m<sup>2</sup> after 15 minutes

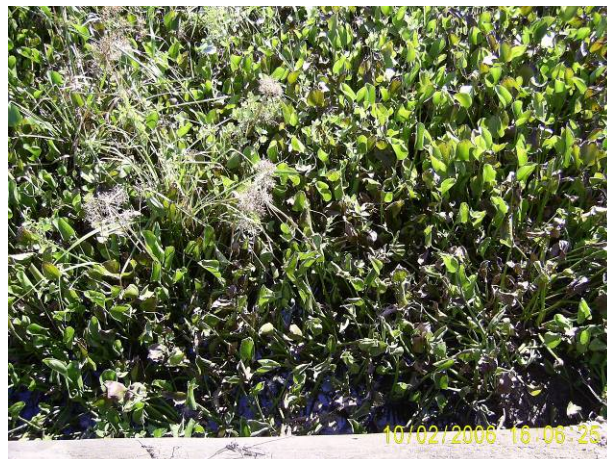
**Figure 5d** Spraying with 100gm/L at 200ml/m<sup>2</sup> after 3 hours

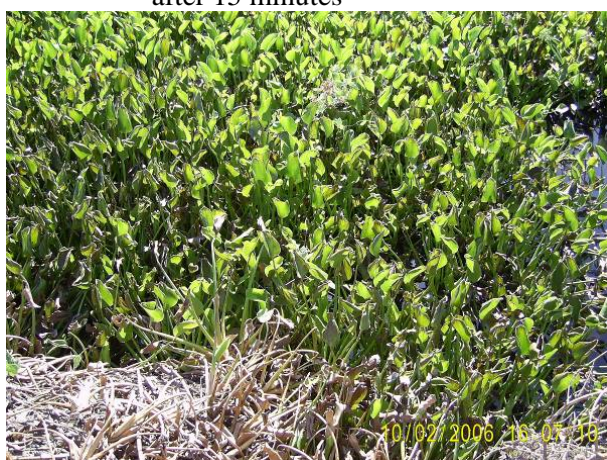
**Figure 5e** Spraying with 200gm/L at 200ml/m<sup>2</sup> after 3 hours

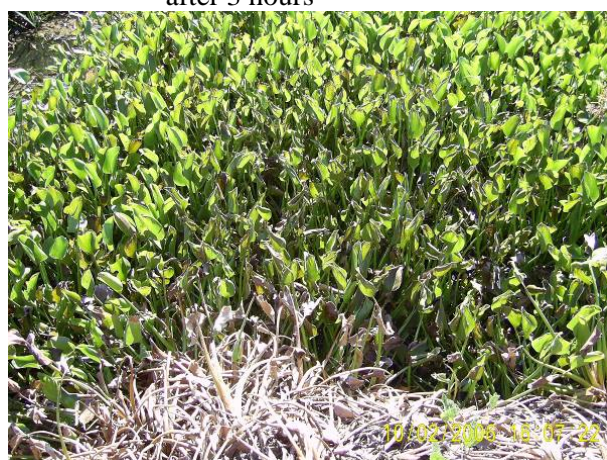
**Figure 5f** Spraying with 400gm/L at 200ml/m<sup>2</sup> after 3 hours

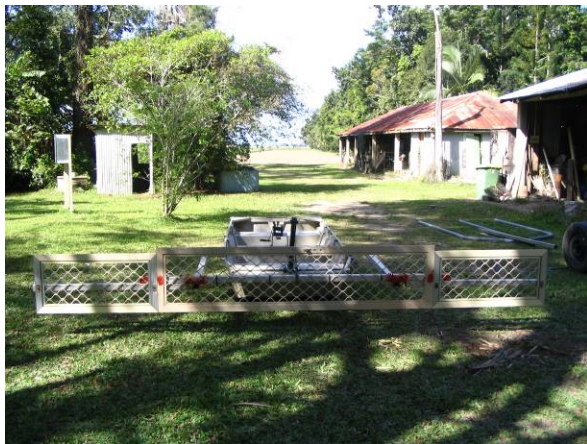
**Figure 6a** Punt fitted with modified security door

It was thought however that the boats could be more effective if fitted with a rake, and a design was developed and built to trial in a second lagoon. Two small boats were fitted with mesh blades of different designs with one design constructed from a discarded security door. The second design used a mesh drop net supported by a floating sealed PVC tube but this proved more cumbersome to operate. Construction and equipment costs for the boat using a discarded security door totalled \$200 plus one day's work by a local stakeholder and a cheap 2nd hand outboard motor costing \$800. The small boats fitted with mesh blades were then able to push much larger weed mats than those used previously without rakes. Rake boats were also effective in pulling weeds from the banks and in collecting smaller patches of weeds that neither the harvester nor unmodified boats were able to clean up (Figure 6a and b).

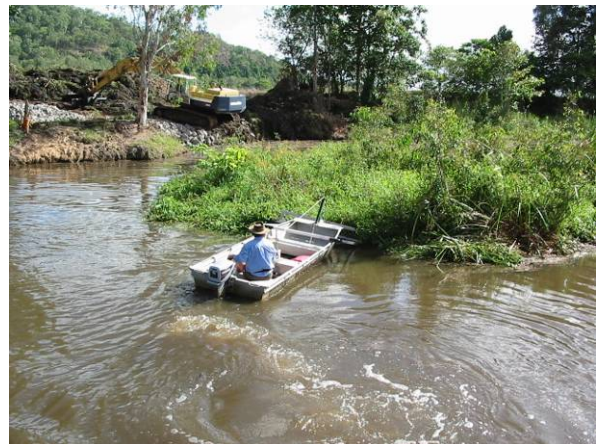
**Figure 6b** Modified punt pushing weed mat

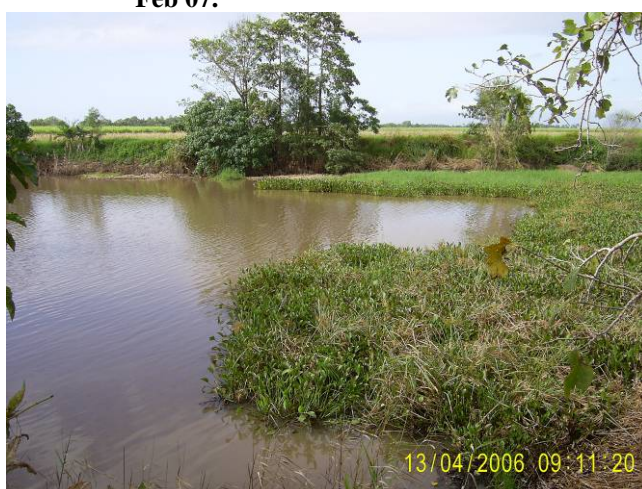
Figure C10: ~200m downstream from Site LC011 Weed mat was flushed out by flood water downstream of this point.

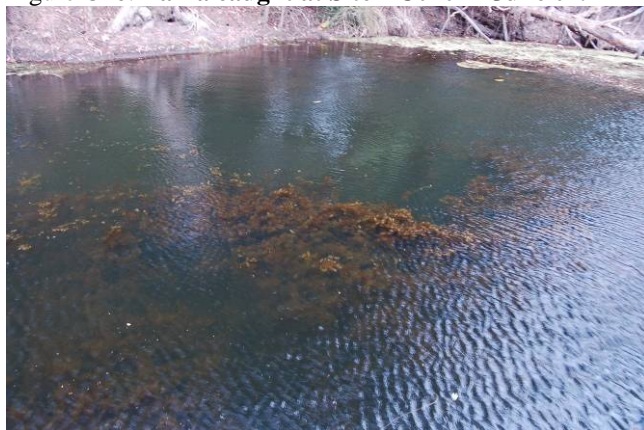
Figure C18: Site LC014 in Jun 07 showing native submerged vegetation and clear water.
